**US Army Corps  
of Engineers**

TECHNICAL REPORT A-83-1

# **AERIAL SURVEY TECHNIQUES TO MAP AND MONITOR AQUATIC PLANT POPULATIONS—FOUR CASE STUDIES**

Environmental Laboratory

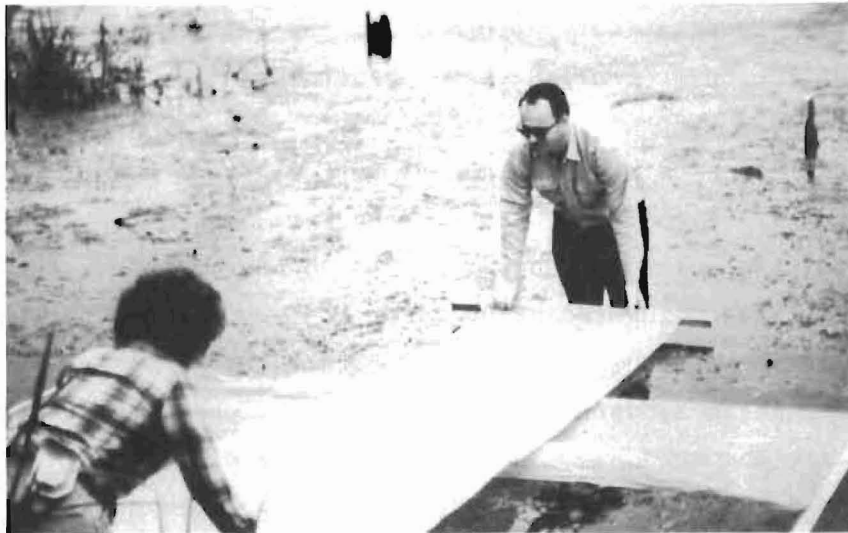
Figure 6. Field team placing reference markers to establish ground control on Lake Seminole

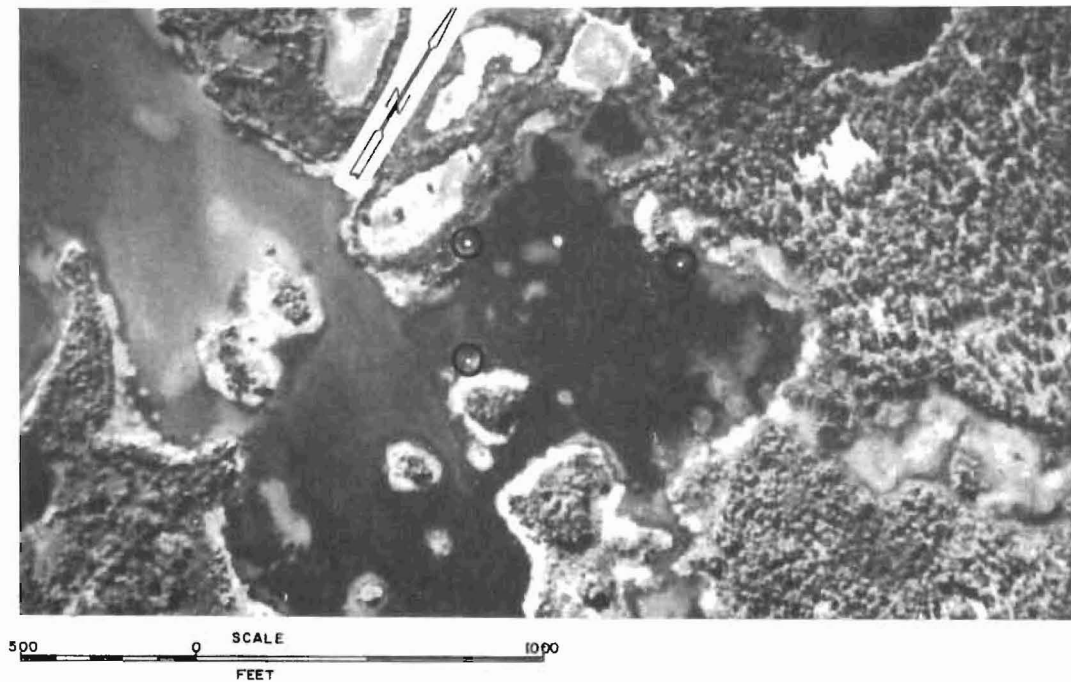
Figure 7. Reference markers used on Lake Seminole (circled) visible on 1979 color imagery

26. Photointerpretation. A skilled WES interpreter, unfamiliar with Lake Seminole, first located all three sets of reference markers (Figure 7) and the nearby surveyed colonies of giant cutgrass. These colonies were then used as training sites to map the areal distribution of giant cutgrass in the remainder of this reservoir. The base map was a 1979 1:24,000-scale, black-and-white, semicontrolled photomosaic (same as used for the boat survey) supplied by SAM. The interpreter traced the outline of the lake shoreline and islands onto a transparent overlay; placed color positive transparencies under the base map overlay;
