## **Invasion of Eurasian Watermilfoil in Lakes of the Western Upper Peninsula, Michigan**

John G. Skogerboe, Angela G. Poovey, Kurt D. Getsinger,  
and Greg Kudray

August 2003

Final report

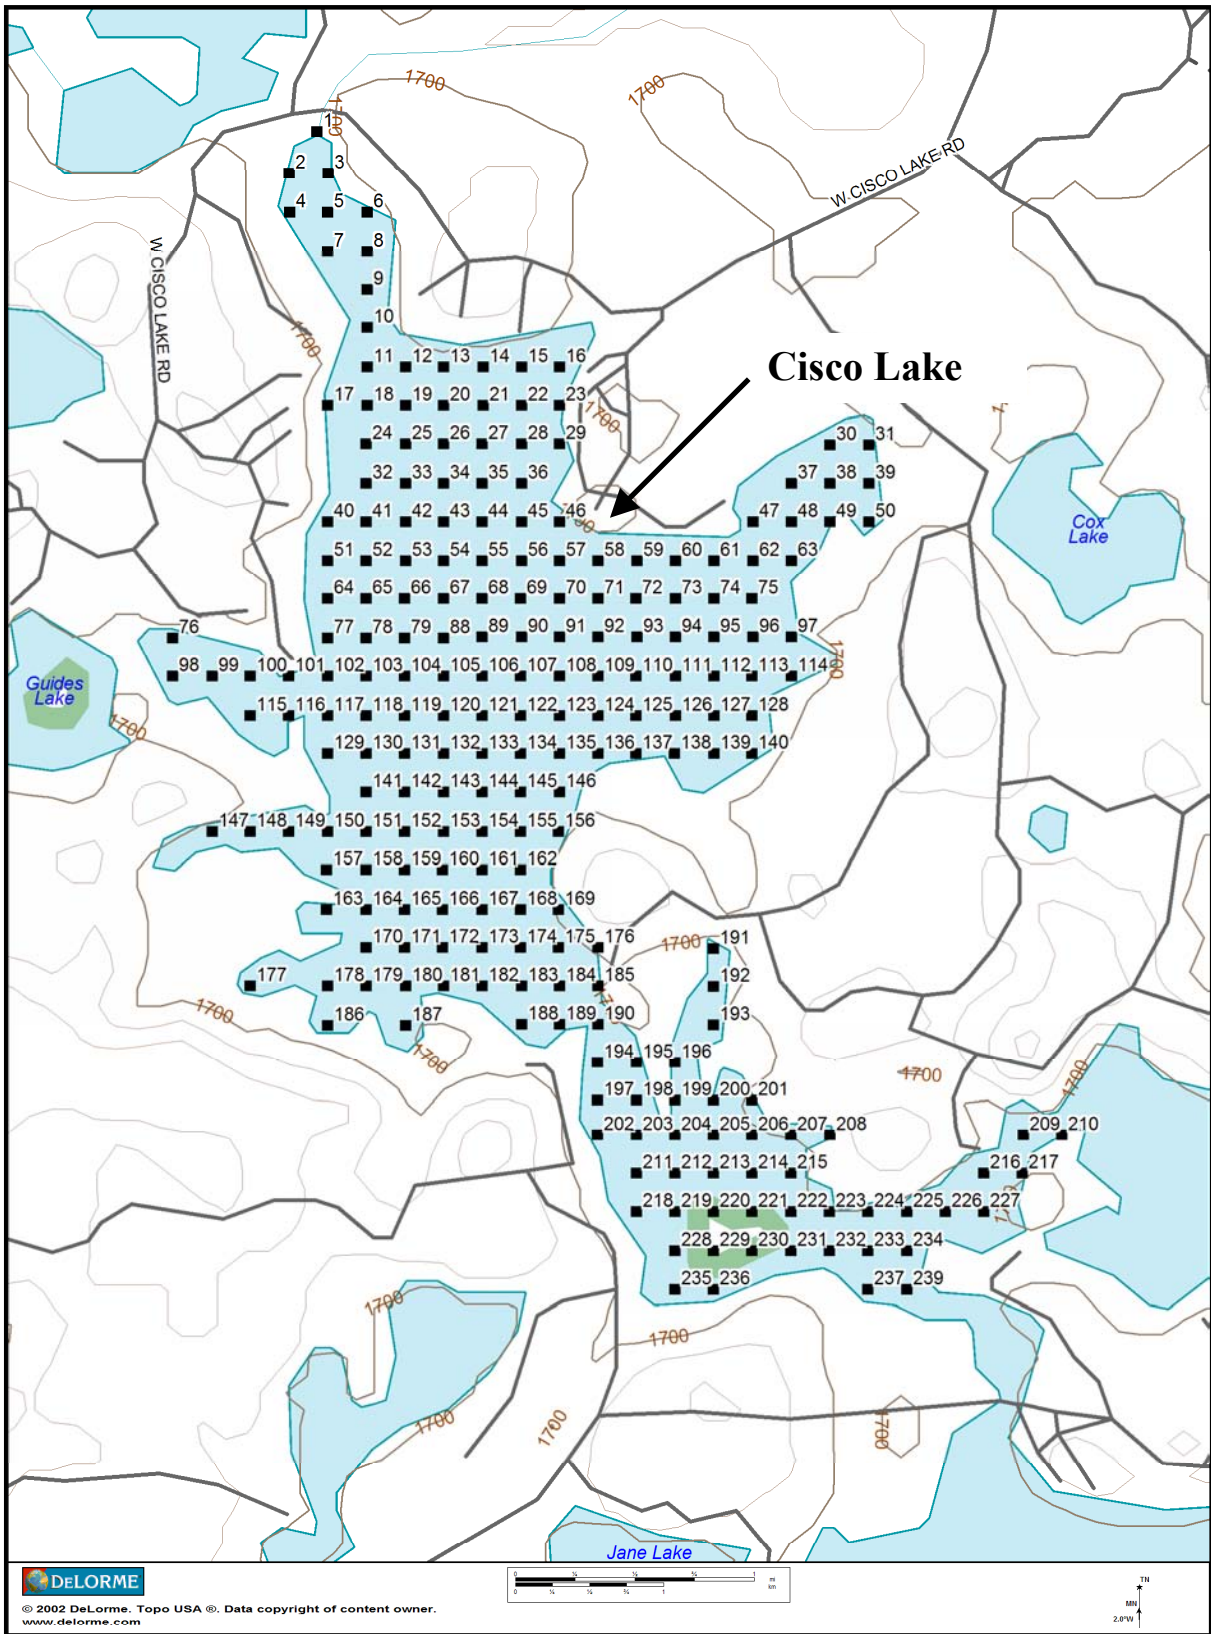
Figure 6. Cisco Lake, Gogebic County, MI, aquatic plant survey locations – 2002. Squares on lake map indicate discrete GPS sampling points

Cisco Lake (Figure 6) is part of the Cisco Chain of Lakes, and has a surface area of 500 acres and a mean depth of 11 ft (Table 1) with a maximum depth of 20 ft. The water was relatively clear with an MRD of 14 ft (Table 1). The lake is

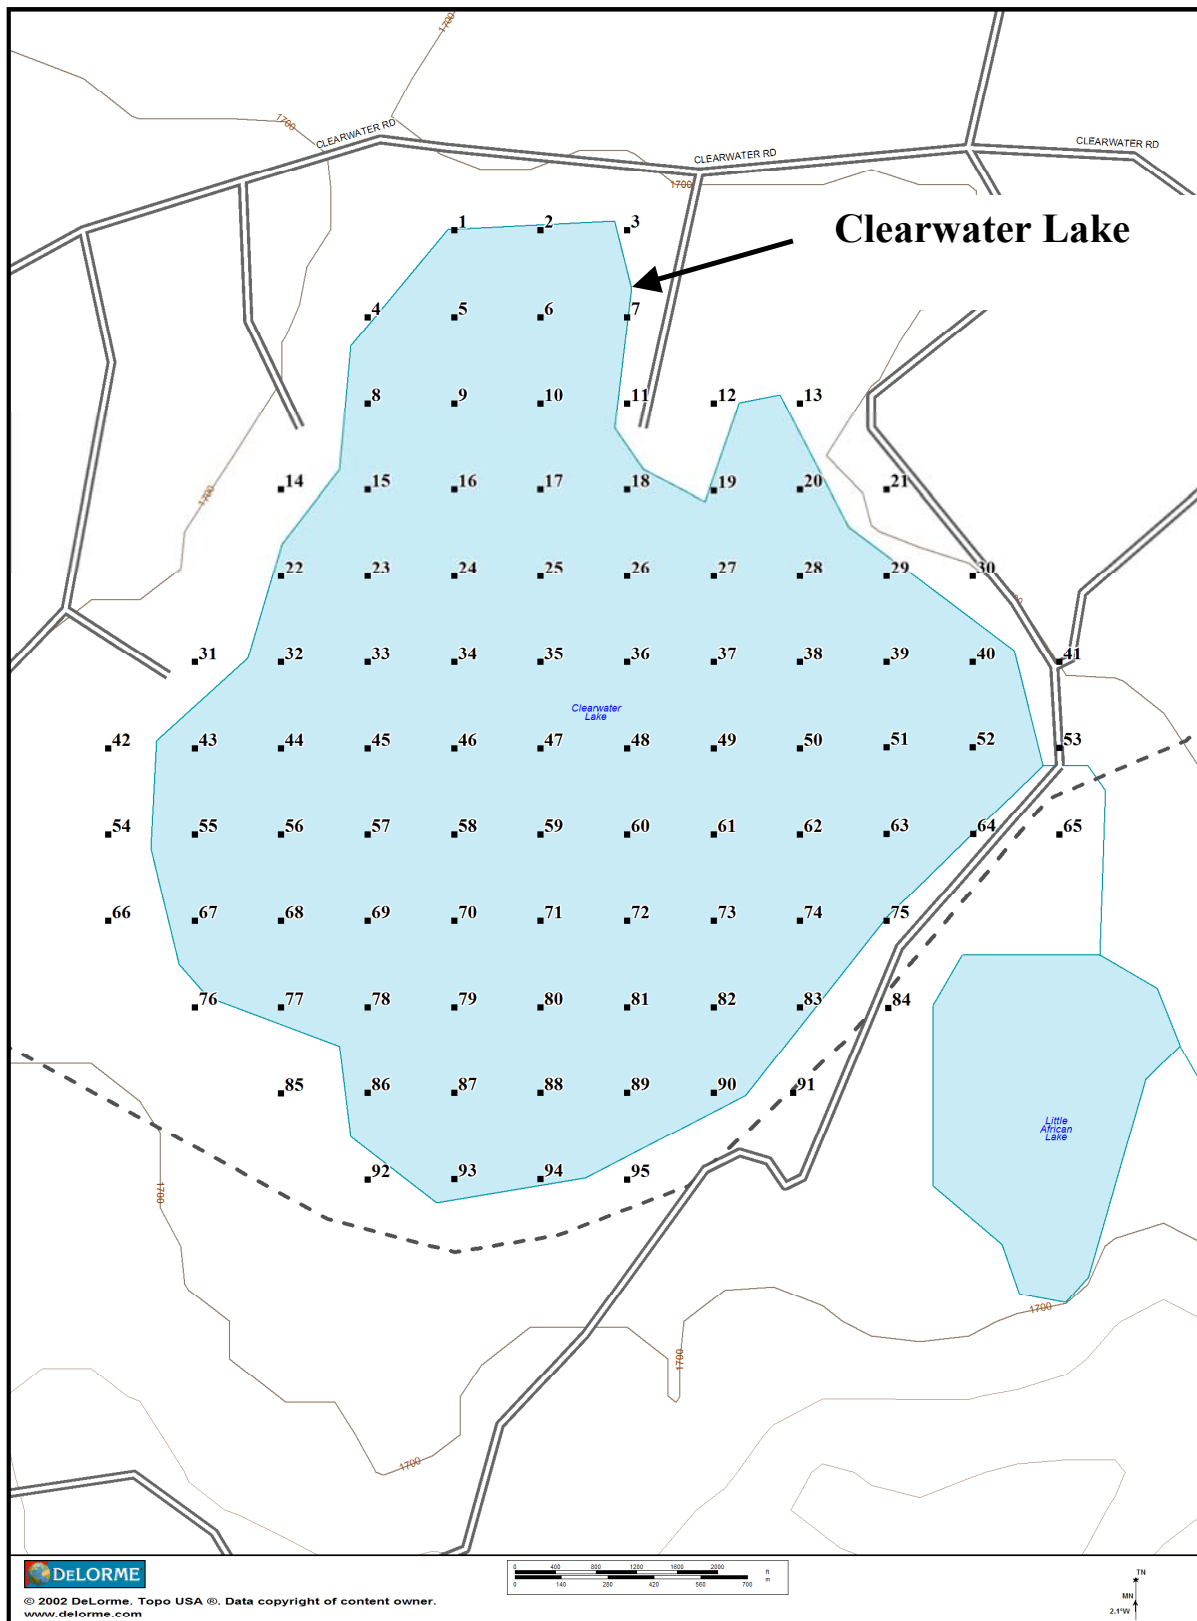
Figure 7. Clearwater Lake, Gogebic County, MI, aquatic plant survey locations – 2002. Squares on lake map indicate discrete GPS sampling points

Clearwater Lake is the site of the first reported Eurasian watermilfoil infestation in the region, where 55 acres of the plant occurred in 2000 (L. Esman, MI-DEQ, pers. comm.). The following year, all infested areas were treated with the aquatic herbicide, 2,4-D. In 2002 no Eurasian watermilfoil was found at any of the sample locations or by visual observation while traversing from one sample point to another. Eurasian watermilfoil could become established in up to

83 percent of the lake based on the MRD. The substrate and plant species that occur in the lake indicated that Eurasian watermilfoil might reach nuisance levels, impacting recreation and aesthetics. Infestations also might adversely impact native submersed plant populations. Once established in Clearwater Lake, Eurasian watermilfoil could quickly spread to other lakes in the Cisco Chain of Lakes via boat traffic, currents, and animals, as was the case when it was found downstream in Little Africa Lake in 2000.

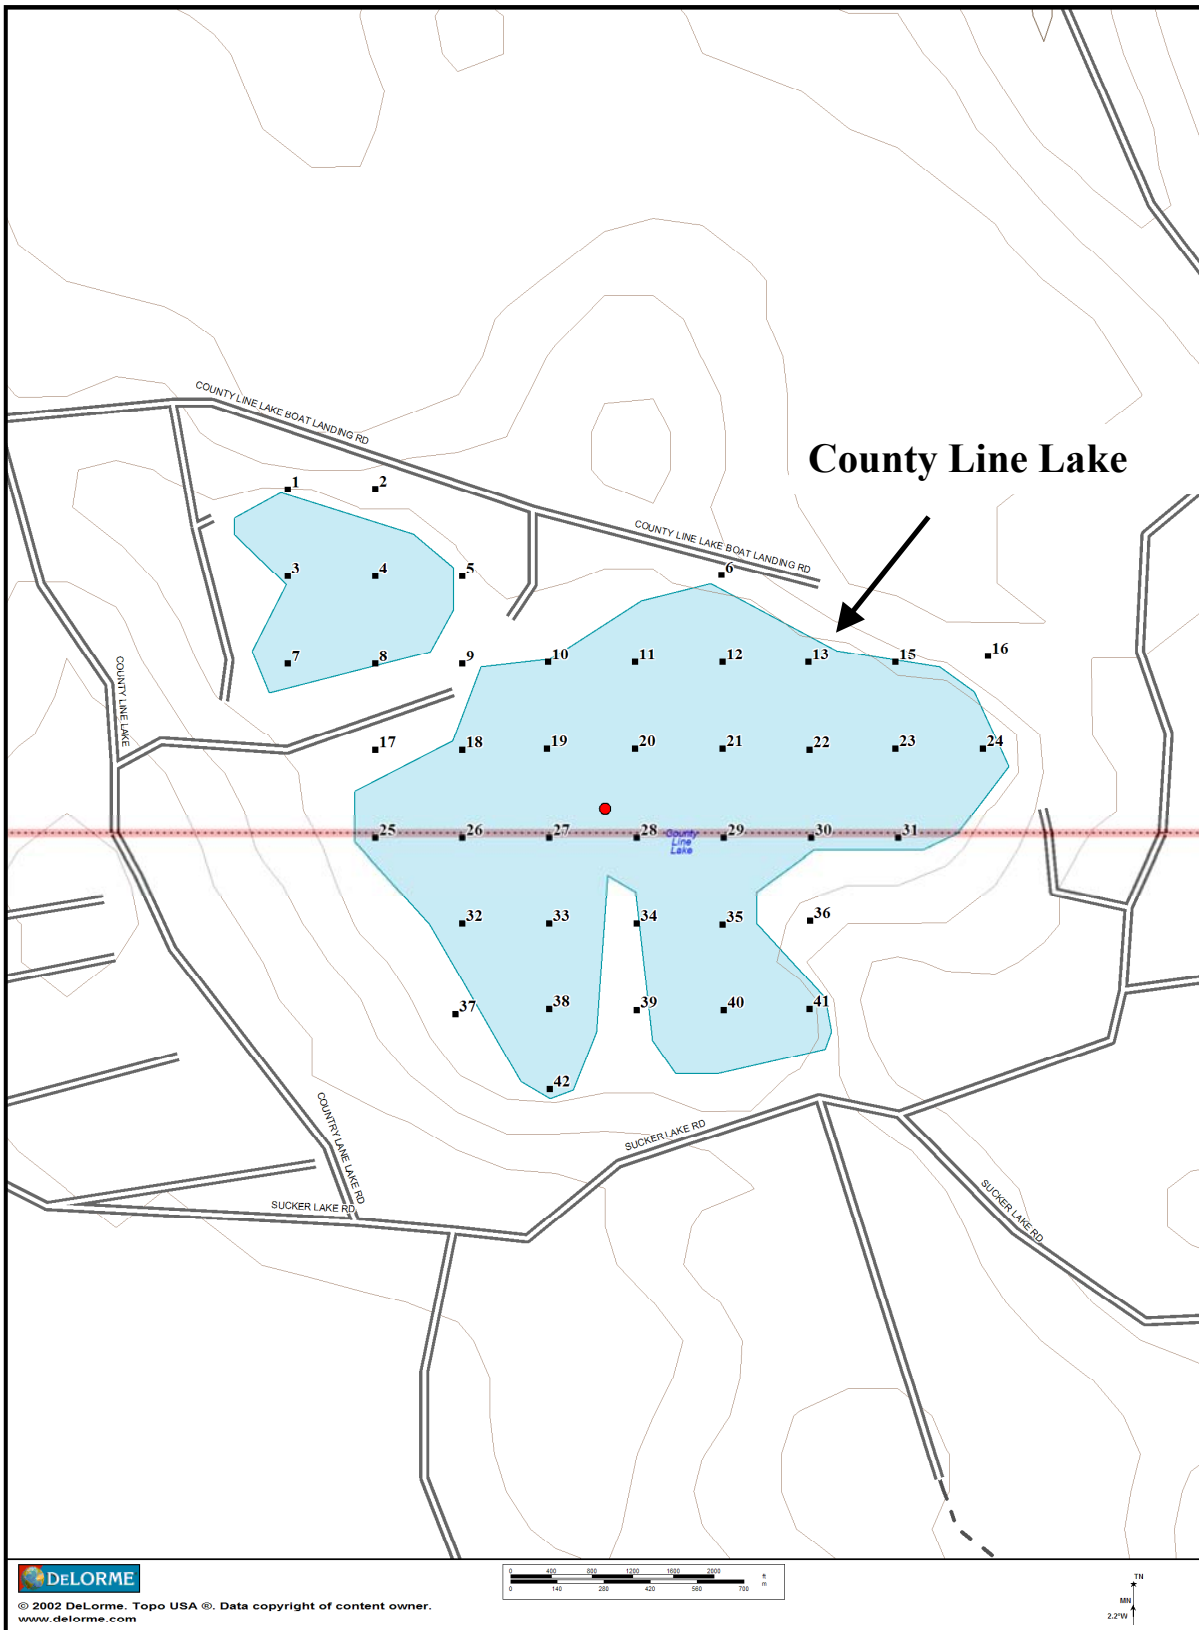
Figure 8. County Line Lake, Gogebic County, MI, aquatic plant survey locations – 2002. Squares on lake map indicate discrete GPS sampling points

County Line Lake has a surface area of 72 acres (Figure 8), a mean water depth of 20 ft (Table 1), and a maximum depth of 65 ft. The water was relatively clear with an MRD of 18 ft (Table 1). Only about 30 percent of the lake has some vegetation based on survey data even though 54 percent of sample points fell within the MRD (Table 2). The substrate was mostly hard bottom consisting of rock, gravel, or sand. The most common plant (Table 8) was the floating leaf plant, *Brasenia schreberi*, and emergent *Sparganium* spp. Submersed species occurred near the shoreline, and included such small plants as *Elatine minima*, *Eleocharis acicularis*, and *Eriocaulon aquaticum*. These plants indicate relatively pristine systems based on their CoC rating. The total number of species

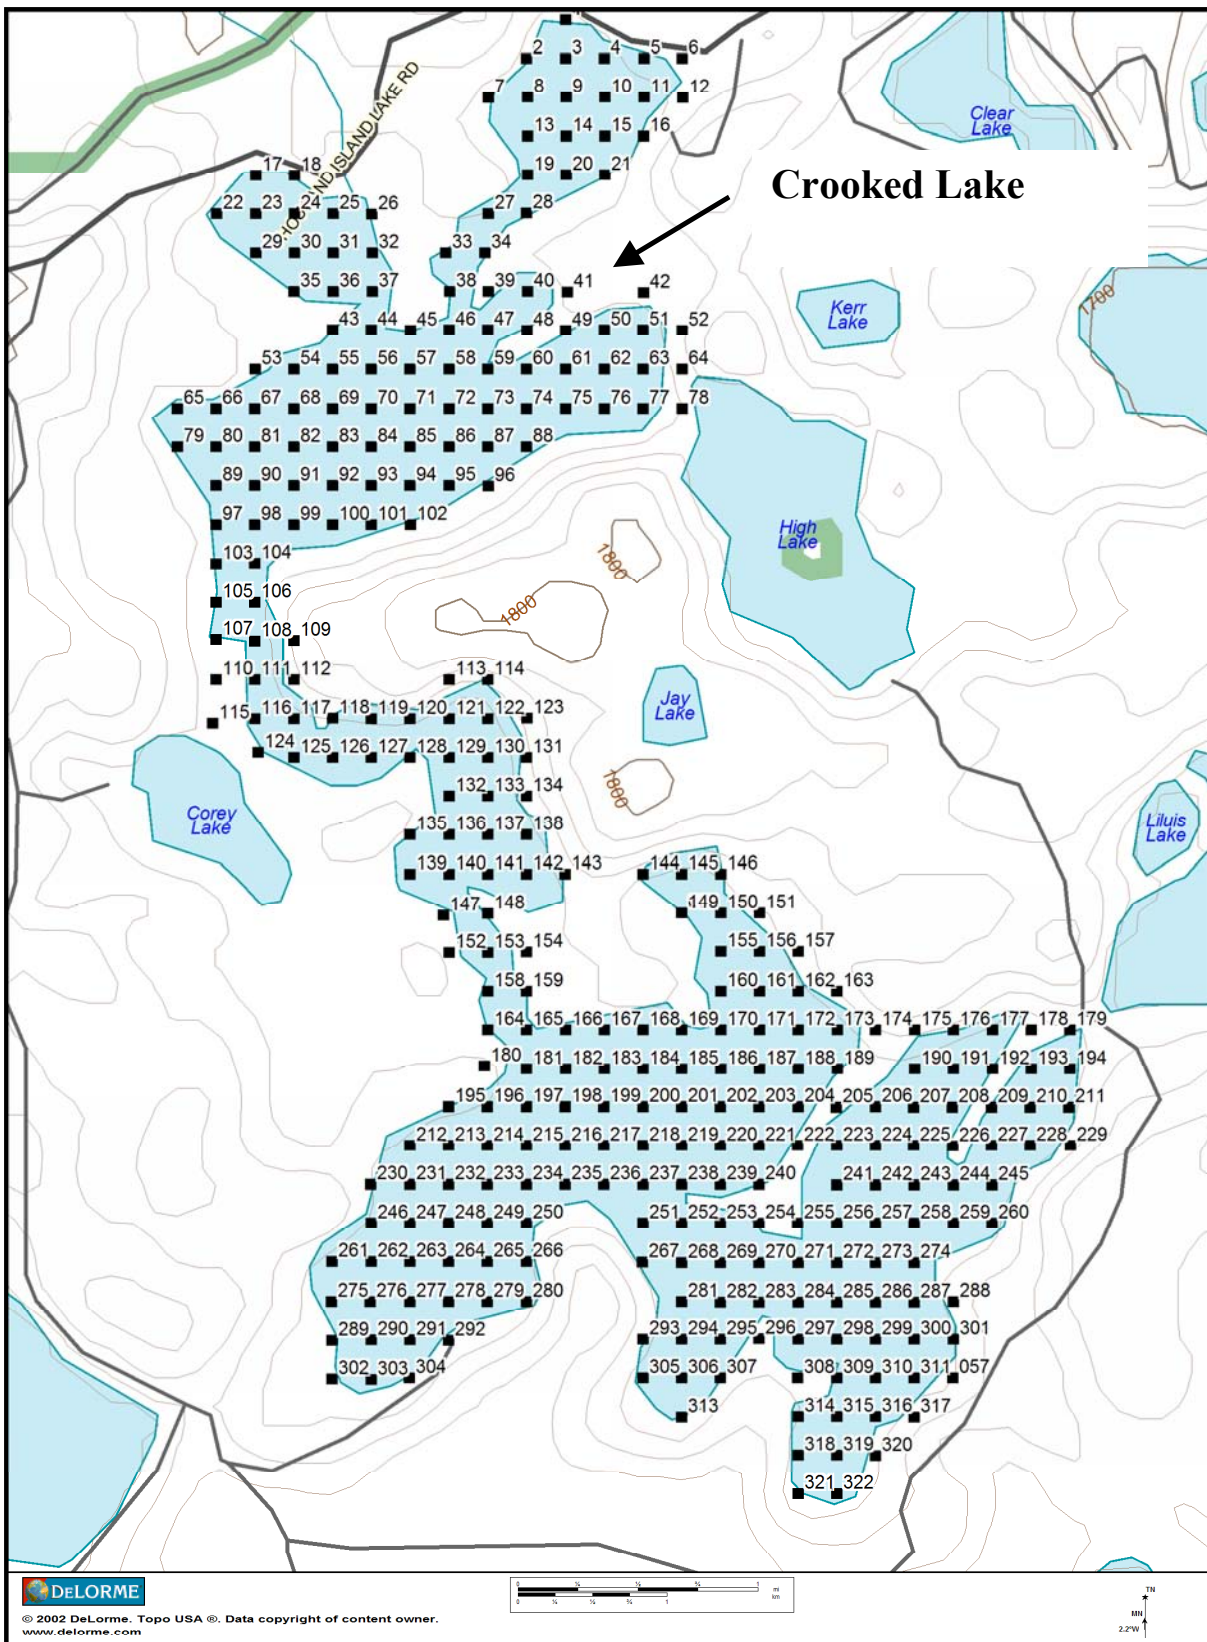
Figure 9. Crooked Lake, Gogebic County, MI, aquatic plant survey locations – 2002. Squares on lake map indicate discrete GPS sampling points

A very small infestation of Eurasian watermilfoil was found near the USFS boat ramp in the northern bay (Figure 9). Five individual plants were found at the site and removed by hand pulling. These samples were destroyed. Although the infestation was controlled, this site should be carefully monitored to ensure that hand-pulling efforts were effective. If more plants are found, the Eurasian watermilfoil should be controlled using aquatic herbicides to prevent spread by boat traffic and animals to other lakes near the SWA. Based on the MRD, Eurasian watermilfoil could become established in up to 69 percent of the lake, which would severely impact recreation and aesthetics and displace native submersed plant populations.

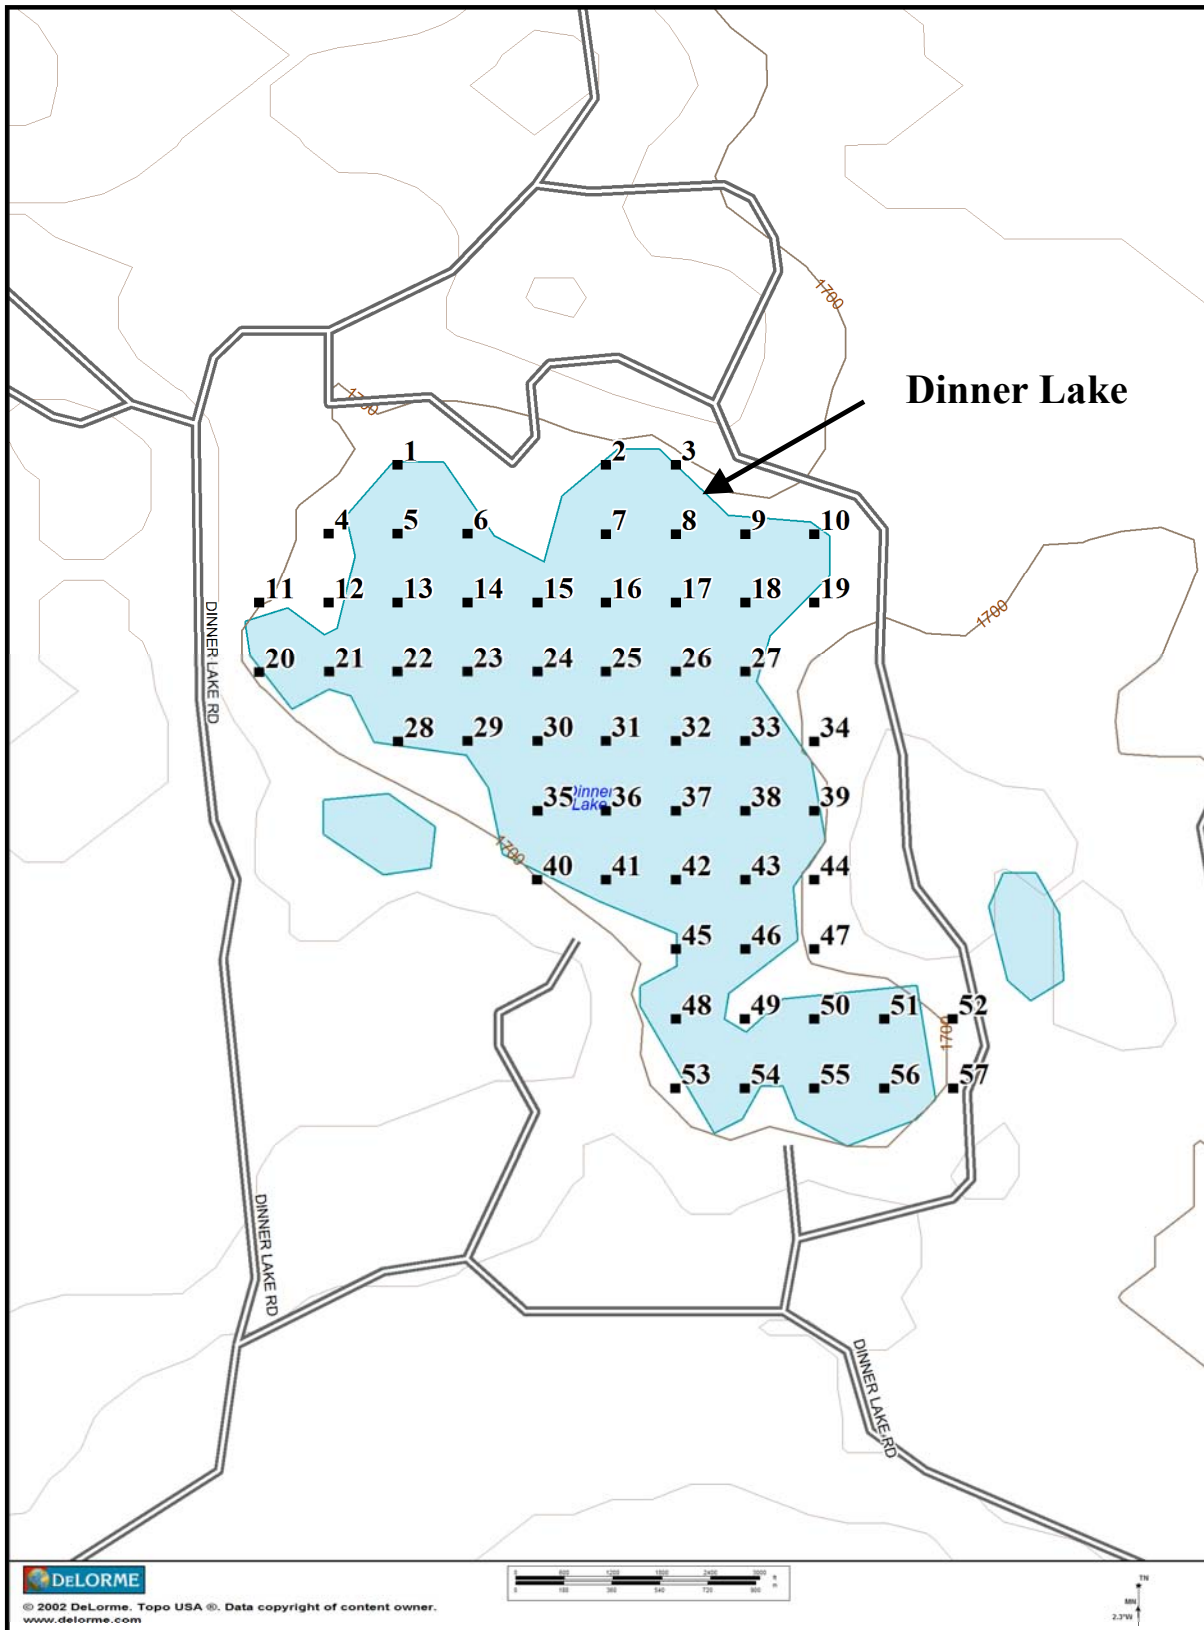
Figure 10. Dinner Lake, Gogebic County, MI, aquatic plant survey locations – 2002. Squares on lake map indicate discrete GPS sampling points

Dinner Lake has a surface area of 106 acres (Figure 10) and a mean water depth of 11 ft (Table 1) with a maximum depth of 25 ft. The water was relatively clear with an MRD of 19 ft (Table 1). Although 90 percent of sample points fell within the MRD, only about 34 percent of the lake has some vegetation based on survey data (Table 2). The substrate was mostly hard bottom consisting of rock, gravel, or sand, and may have prevented the colonization of a larger plant community. The most common species was the floating leaf plant, *Nymphaea odorata* (Table 10). Common submersed plant species included *Vallisneria americana* and *Sagittaria graminea*. Submersed species occurred mostly in very

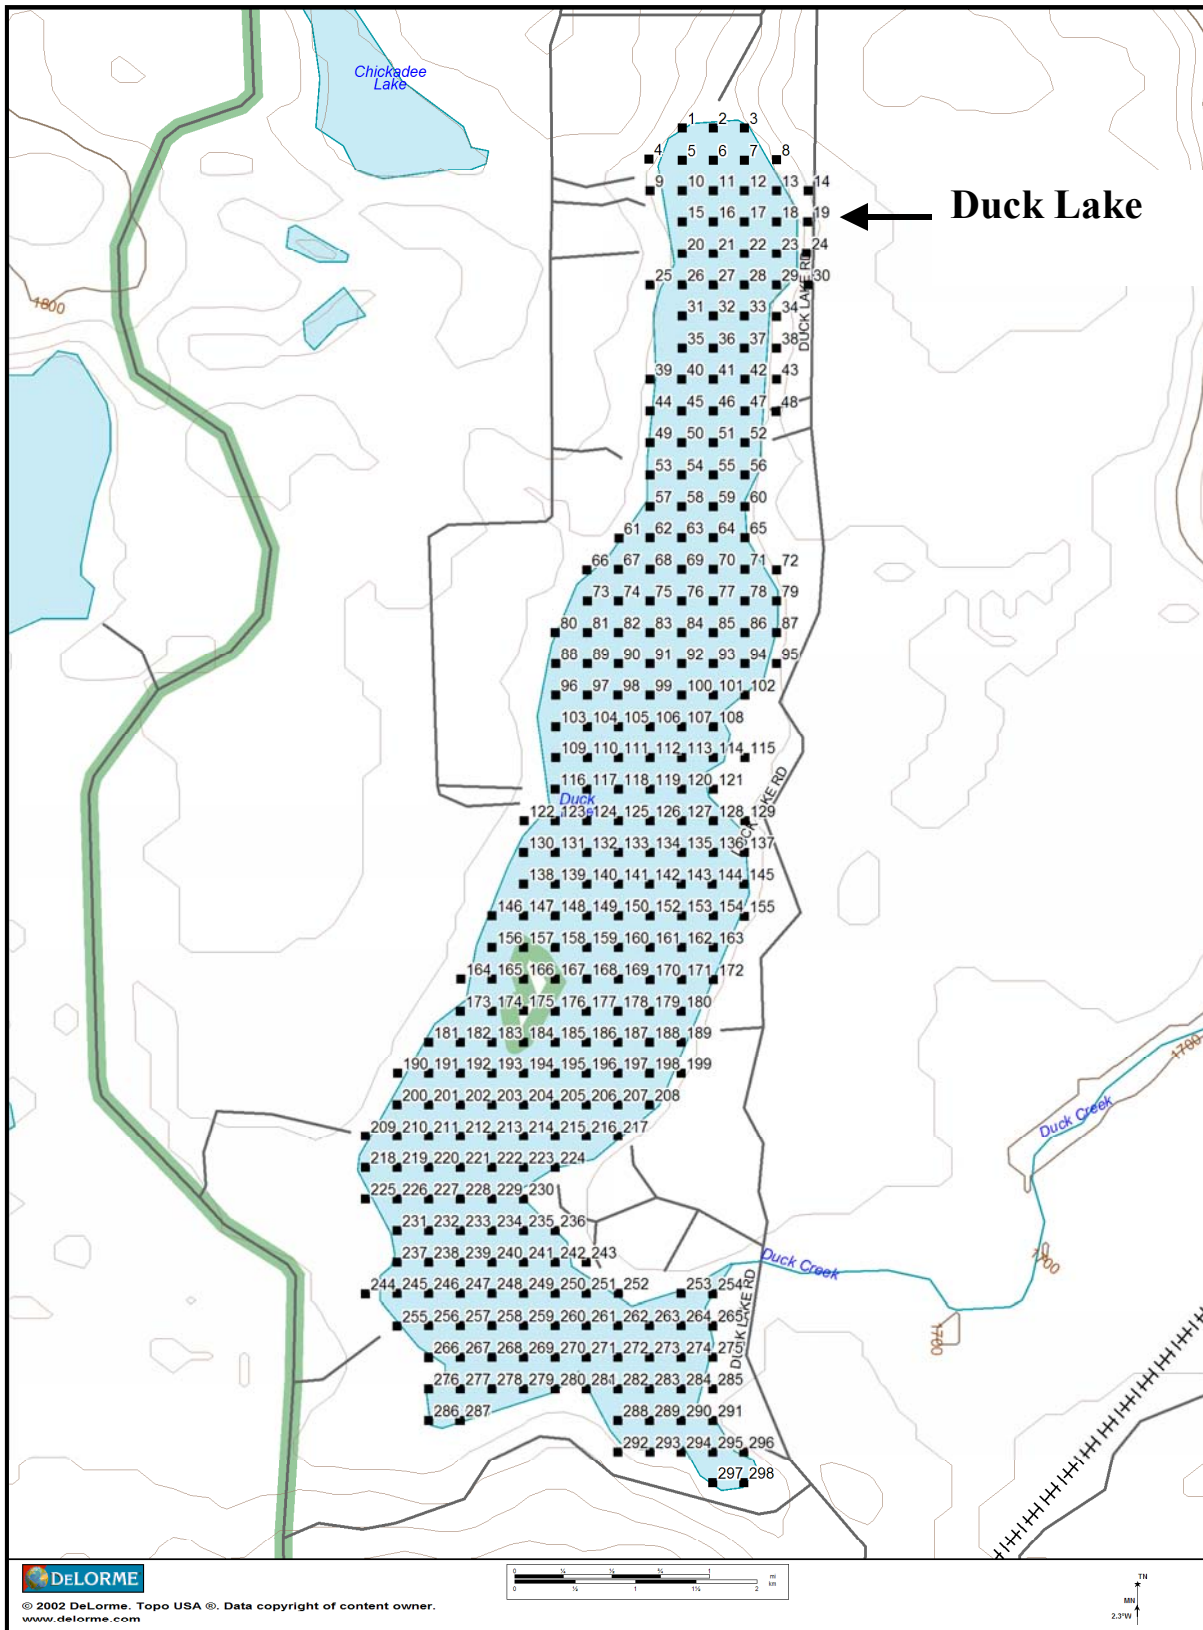
Figure 11. Duck Lake, Gogebic County, MI, aquatic plant survey locations – 2002. Squares on lake map indicate discrete GPS sampling points

Duck Lake has a surface area of 610 acres (Figure 11), a maximum water depth of 25 ft, and a mean depth of 7 ft (Table 1). A sizable island is located in the west central part of the lake. The shoreline is mostly developed, although houses are typically on large lots leaving considerable amounts of undisturbed lakeshore. The water was relatively clear with an MRD of 15 ft (Table 1). A small creek flows into the north end of the lake. The area around the inlet had a soft organic substrate with depths within the MRD. Otherwise, the northern half of the lake east and north of the island was deeper than the MRD, except for a narrow band along the shoreline before a generally steep drop-off to deeper water. A shallow heavily vegetated area within the MRD occurred between the island and the west shore. The outlet of the lake, Duck Creek, is at the southern end of the lake. The southern one-third of the lake had a gradually sloping to level, mostly organic bottom that is within the MRD. Based on the MRD, Eurasian watermilfoil could colonize 47 percent of the lake. About 44 percent

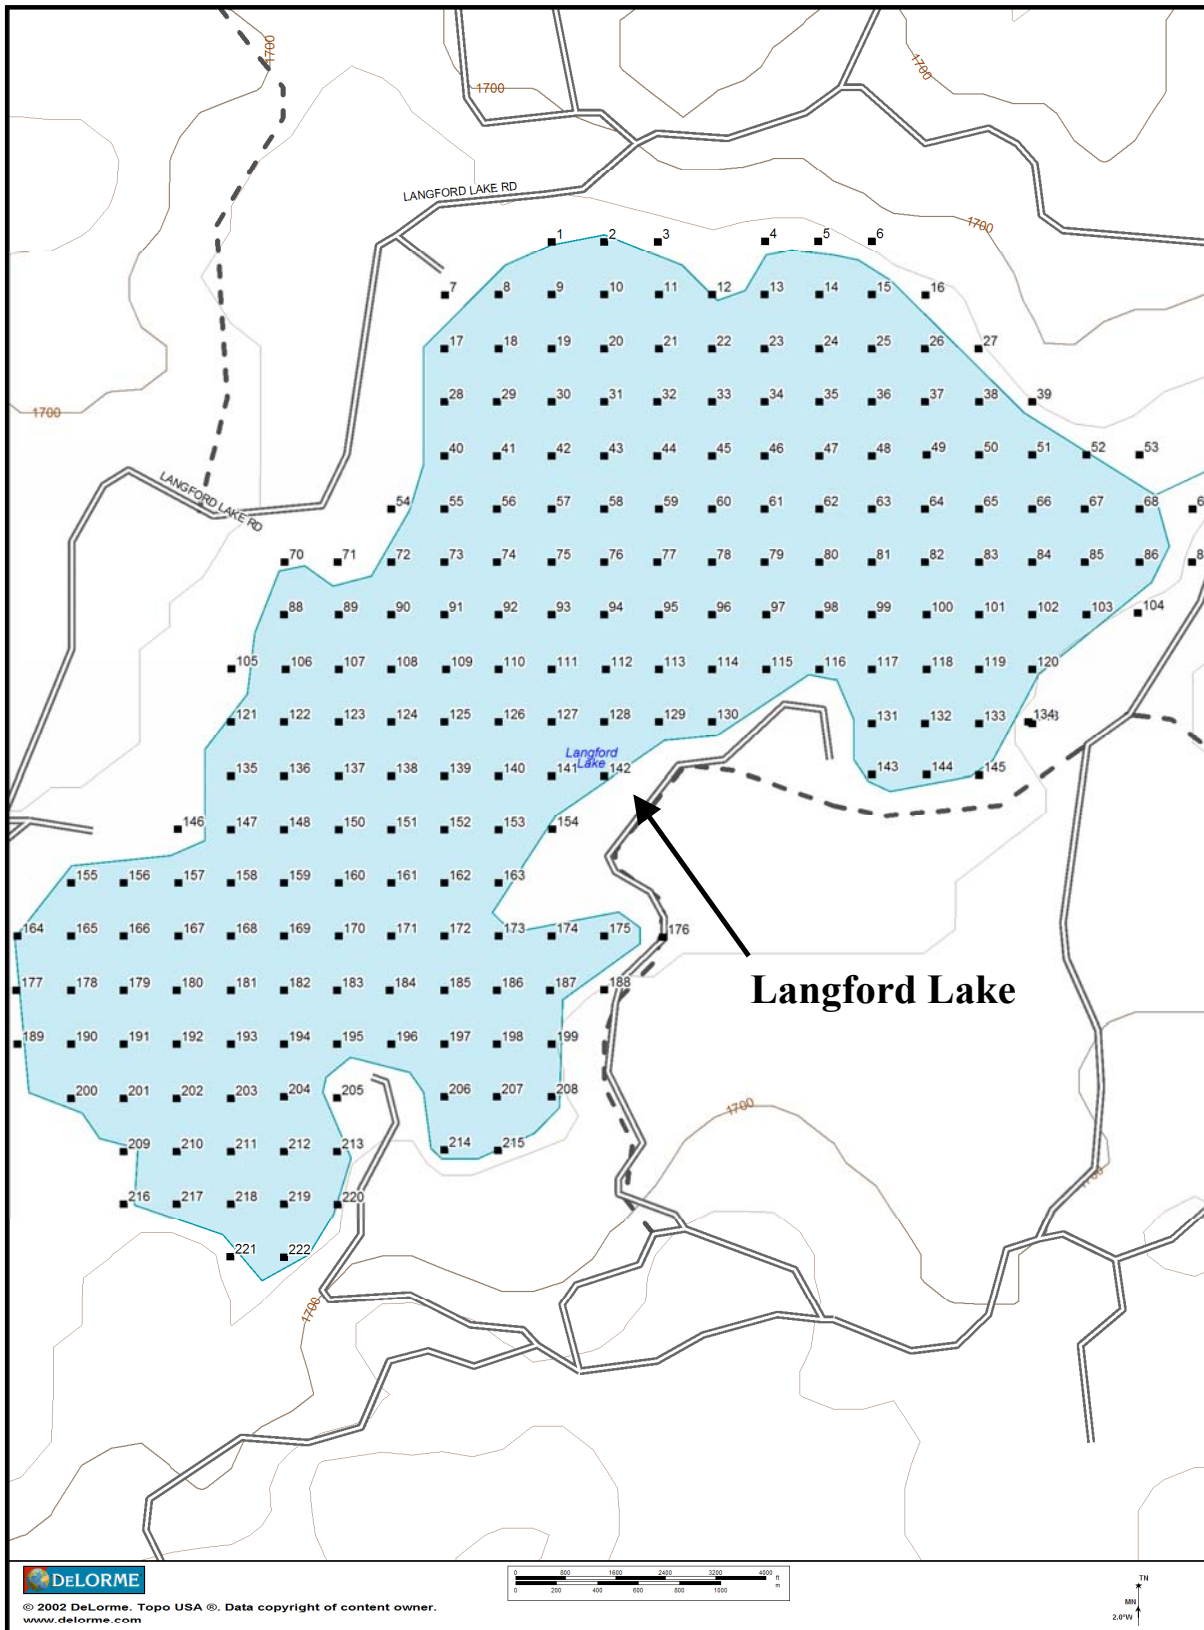
Figure 13. Langford Lake, Gogebic County, MI, aquatic plant survey locations – 2002. Squares on lake map indicate discrete GPS sampling points

The surface area of Langford Lake is 476 acres (Figure 13) with a mean depth of 8 ft (Table 1). The water in the lake was very clear with an MRD of 26 ft (Table 1). The lakeshore consists partly of permanent and summer lake homes, and the remainder is a portion of the Ottawa National Forest. The public boat ramp and campground on the northeast side of the lake is managed by the USFS. About 46 percent of the lake has some vegetation based on survey data, and 65 percent of sample locations fell within the MRD (Table 2). Much of the substrate is soft sediments with sufficient nutrients to support large stands of pondweeds (Table 13) including *Potamogeton amplifolius*, *P. gramineus*, *P. richardsonii*, *P. robbinsii*, and *P. zosteriformis*. A total of 31 species were collected, which was the most for any lake surveyed, and the  $I$  was 37.1. The  $CoC_{avg}$  rating was 6.8. Eurasian watermilfoil was found near the USFS boat ramp on the west side of the bay (Figure 13), scattered in a 100-yd strip in front of the ramp and campground out to about 20 yd from shore. Eurasian watermilfoil could become established in up to 65 percent of the lake based on the MRD. The substrate and plant species that occur in the lake indicate that Eurasian watermilfoil could reach nuisance levels with respect to recreation and aesthetics. Infestations could also have significant adverse impacts on the submersed plant populations. Once established in Langford Lake, Eurasian watermilfoil could spread to other lakes in the area via boat traffic, the outflow stream, and animals. The present infestation is very small, but is probably too large to be controlled effectively by SCUBA divers and hand-pulling techniques. Therefore, the infested area should be treated as soon as possible with an approved aquatic herbicide. The site should then be carefully monitored to ensure that the herbicide application was effective. In many cases, a second herbicide application or more hand pulling may be necessary to eradicate the infestation.

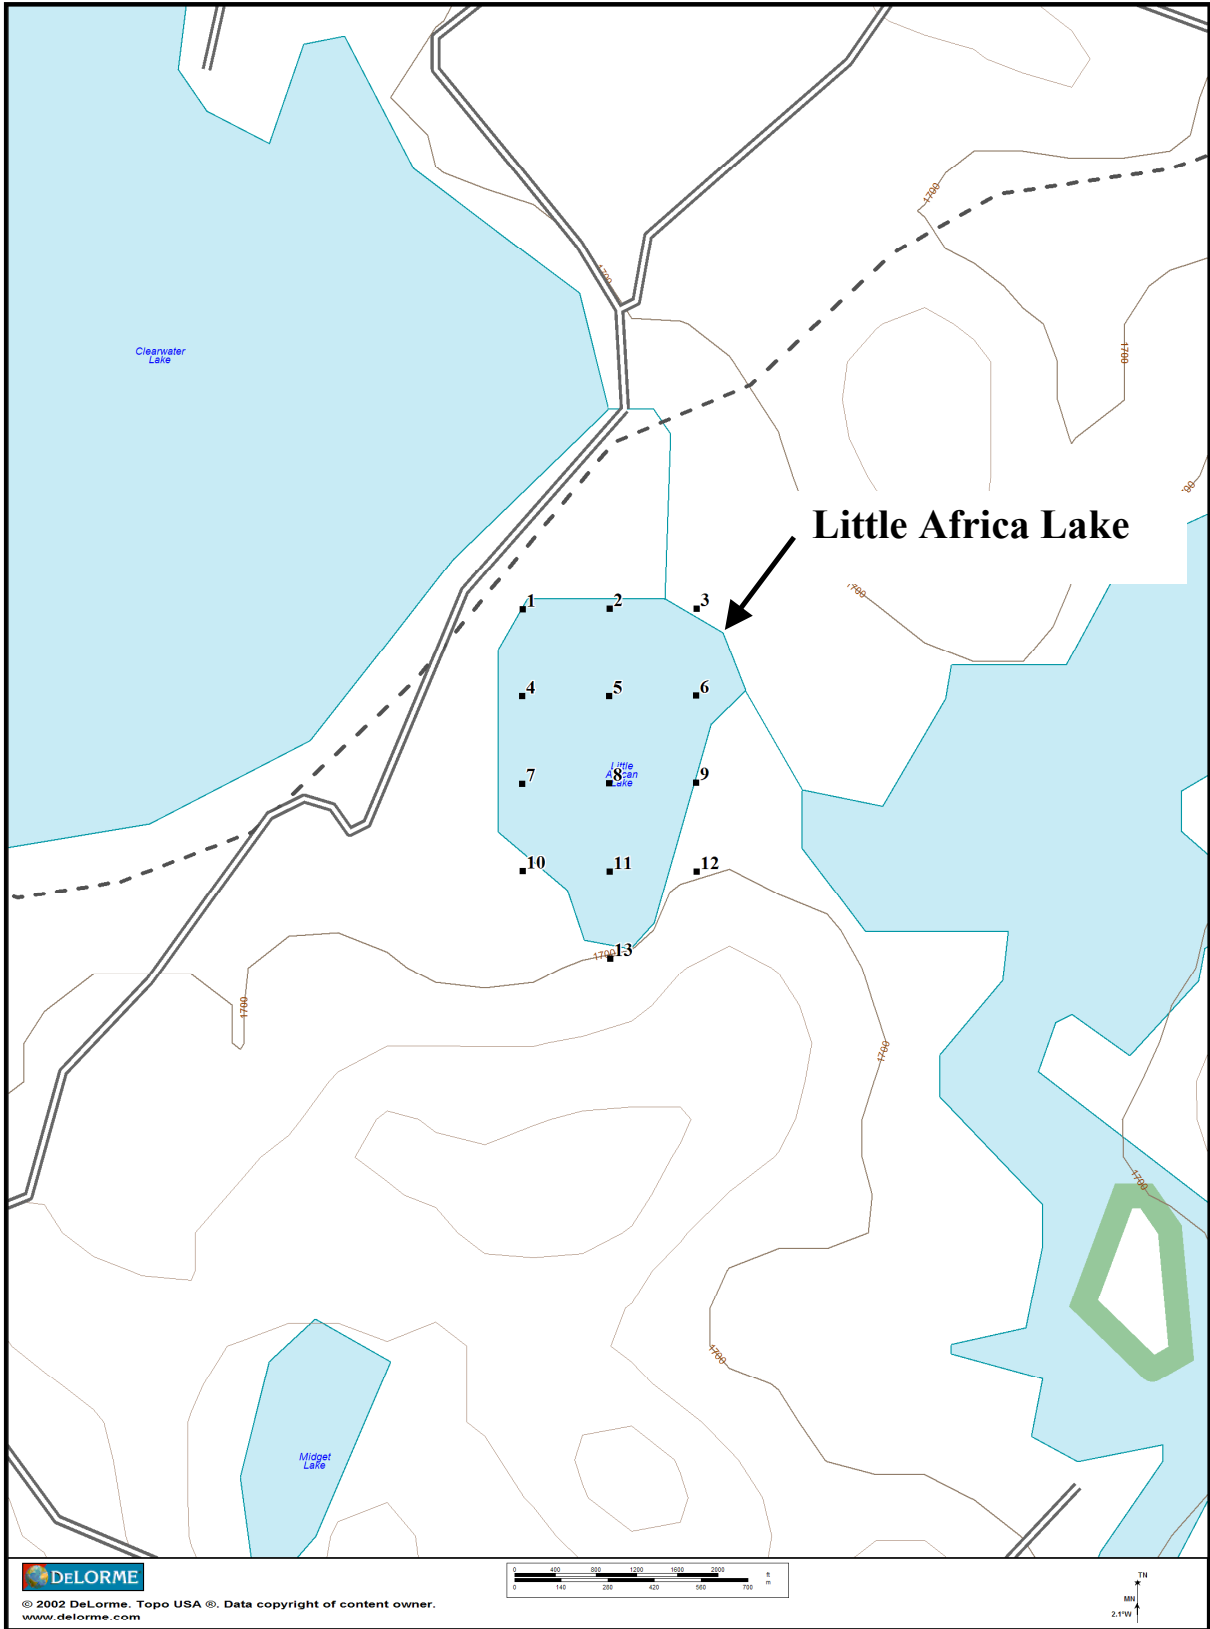
Figure 14. Little Africa Lake, Gogebic County, MI, aquatic plant survey locations – 2002. Squares on lake map indicate discrete GPS sampling points

Little Africa Lake is part of the Cisco Chain of Lakes. The lake is between Clearwater and Big Africa Lakes and is connected to both by a stream. The surface area is 18 acres (Figure 14), with a mean depth of 7 ft (Table 1). The MRD of the lake is 9 ft (Table 1). Little Africa Lake does not have a public access boat ramp; however, a small infestation of Eurasian watermilfoil occurred in 2000, probably transported to the site by the stream flowing in from Clearwater Lake. An area of less than 1 acre was treated with the aquatic herbicide 2,4-D in summer 2001. About 58 percent of the lake has some vegetation based on survey data, and 58 percent of sample locations fell within the MRD (Table 2). No homes were built along the lake. The substrate consisted mostly of soft sediments with sufficient nutrients to support large stands of pondweeds (Table 14) including *Potamogeton amplifolius*, *P. epihydrus*, *P. richardsonii*, *P. robbinsii*, and *Stuckenia pectinata*. Other common species included the floating leaf plants, *Nuphar lutea ssp variegata*, *Nymphaea*, and *Brasenia schreberi*, emergent plants including *Pontedaria cordata* and *Sparganium augustifolium*. *Utricularia vulgaris* and *Ceratophyllum demersum* were also common. Little Africa Lake had a CoC<sub>avg</sub> rating of 6.7 and an *I* of 23.9. No Eurasian watermilfoil was found at any of the sample locations or by visual observation while traversing from one sample point to another. Eurasian watermilfoil could become established in up to 58 percent of the lake based on the MRD and plant survey data. The substrate and plant species that occur in the lake indicate that Eurasian watermilfoil could reach nuisance levels with respect to recreation and aesthetics. Infestations could also have significant adverse impacts on the submersed plant populations. Once established in Little Africa Lake, Eurasian watermilfoil could quickly spread to other lakes in the Cisco Chain of Lakes via boat traffic, water currents, and animals as was the case when Eurasian watermilfoil was found downstream from Clearwater Lake, in Little Africa Lake in 2000, and in Big Africa Lake in 2002. The herbicide application conducted in summer 2001 was very effective. No Eurasian watermilfoil was found in Little Africa Lake in summer 2002, but the lake continued to support native aquatic plants, including 13 different species, at 58 percent of the sample locations.

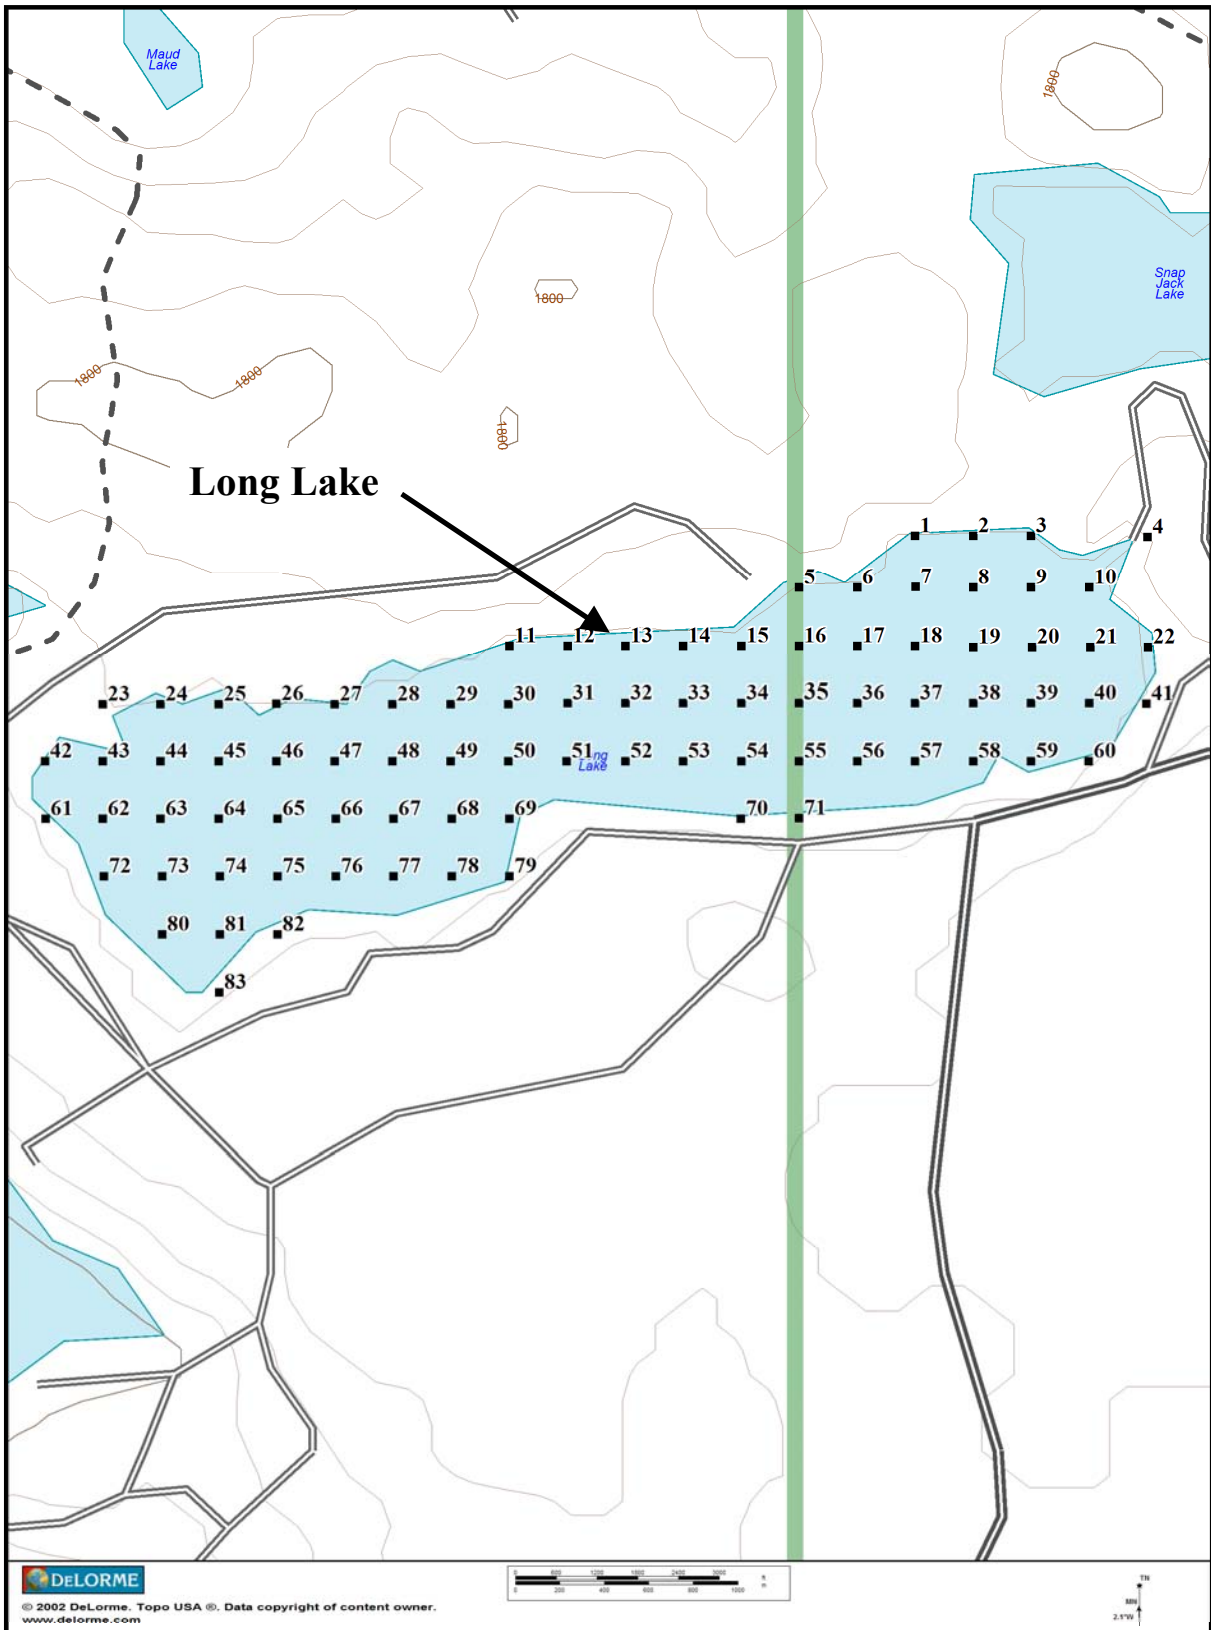
Figure 15. Long Lake, Gogebic County, MI, aquatic plant survey locations – 2002. Squares on lake map indicate discrete GPS sampling points

Long Lake has a surface area of 168 acres, a mean depth of 15 ft (Table 1), and a maximum depth of about 60 ft in the eastern end of the lake (Figure 15). A rocky reef reaches up to within a few feet of the surface directly across from the boat ramp at the same end of the lake. The lakeshore is mostly undeveloped. Most of the shoreline gradually slopes into deeper water, although a few areas have steep drop-offs. A small inlet stream comes in at the west end of the lake. The water was relatively clear with an MRD of 18 ft (Table 1). About 50 percent of the lake has some vegetation based on survey data, and 65 percent of sample locations fell within the MRD (Table 2). *Eleocharis smallii* forms an emergent community sometimes mixed with *Carex lasiocarpa* on shallow flats, most common on the north shore of the lake, but also on the south shore at the west end of the lake. Otherwise, Long Lake was dominated by a low-growing vegetative community (Table 15) with *Myriophyllum tenellum* being the most common species, occurring in 50 percent of all plots (Table 3). Associated species included *Eriocaulon aquaticum* (18 percent), *Eleocharis acicularis* (16 percent), *Isoetes* spp (16 percent), and *Isoetes lacustris* (14 percent). *Isoetes* spp collections were often difficult to identify to species due to the fragmentary nature of many of the collections; these were likely *Isoetes lacustris*. Aquatic mosses also were common but not recorded. Pondweeds were not common in this lake, although *Potamogeton natans* was a dominant in shallow bays at the northwest end of the lake. *Gratiola aurea*, an STE, was quite common (23 percent). A total of 17 native plant species were found, the *I* was 34, and the overall CoC<sub>avg</sub> was 7.8. Eurasian watermilfoil could become established in up to 50 percent of the lake based on the MRD. The substrate and plant species that occur in the lake indicate that Eurasian watermilfoil may not reach nuisance levels with respect to recreation and aesthetics. Localized infestations, however, could significantly displace native submersed plant populations.
