## **Invasion of Eurasian Watermilfoil in Lakes of the Western Upper Peninsula, Michigan**

John G. Skogerboe, Angela G. Poovey, Kurt D. Getsinger,  
and Greg Kudray

August 2003

Final report

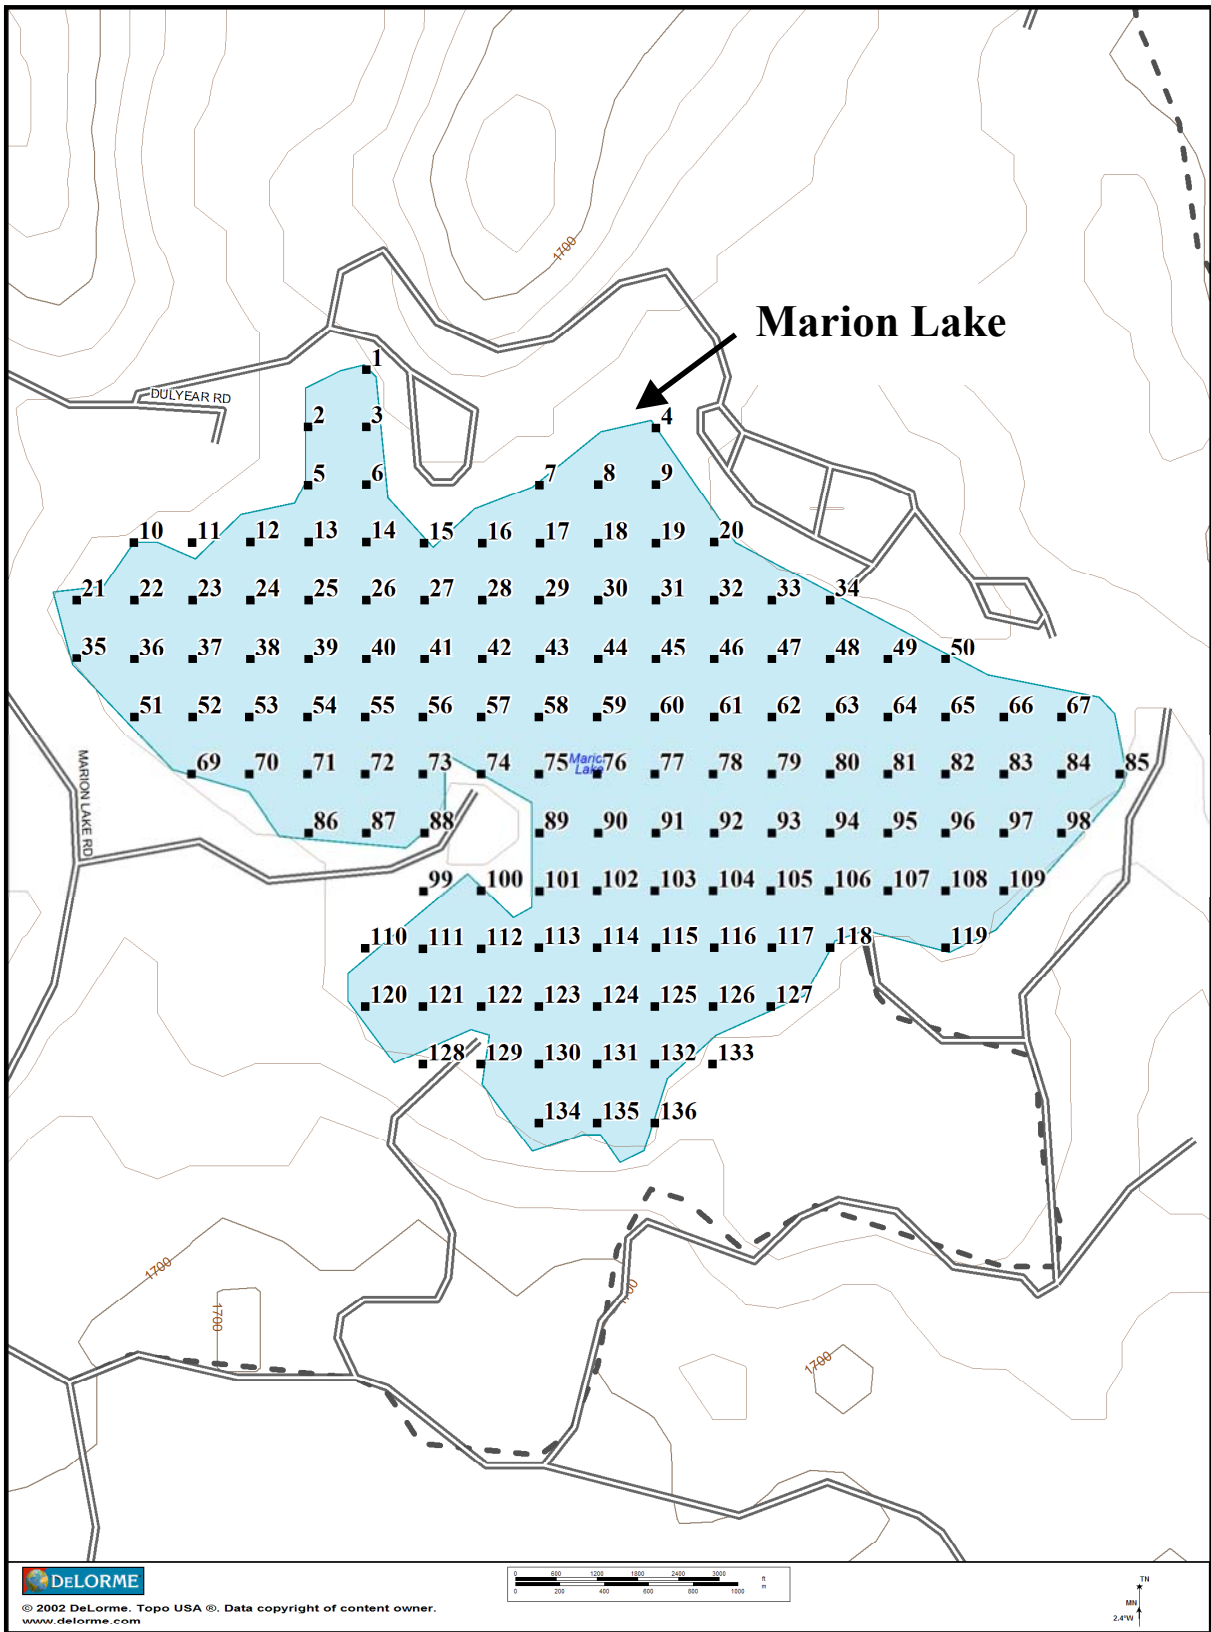
Figure 16. Marion Lake, Gogebic County, MI, aquatic plant survey locations – 2002. Squares on lake map indicate discrete GPS sampling points

Marion Lake has a surface area of 252 acres (Figure 16), with a mean depth of 17 ft (Table 1). The water was relatively clear with an MRD of 17 ft (Table 1). Only about 25 percent of the lake has some vegetation based on survey data, even though 57 percent of sample points fell within the MRD (Table 2). The substrate was mostly hard bottom consisting of rock, gravel, or sand. Aquatic vegetation was sparse and scattered. The most common species (Table 16) was the floating leaf plant, *Nymphaea odorata*. Submersed species occurred mostly in very shallow water, and included small plants such as *Eriocaulon aquaticum*, *Juncus pelocarpus*, *Lobelia dortmanna*, and *Myriophyllum tenellum*, which are indicative of relatively pristine systems based on their COC<sub>avg</sub> rating. One dense stand of *Potamogeton amplifolius* was located at the northeast end of the lake, and according to residents the stand had appeared only in the last couple of years. The total number of species was 19, the *I* was 31.8, and the CoC<sub>avg</sub> rating was 7.3. Eurasian watermilfoil could become established in up to 57 percent of the lake based on the MRD. The substrate and plant survey data indicated that Eurasian watermilfoil may not reach widespread nuisance levels with respect to recreation and aesthetics. The existence of the dense stand of *P. amplifolius* suggested that Eurasian watermilfoil could reach nuisance levels in localized areas. Localized infestations could significantly displace native submersed plant populations.

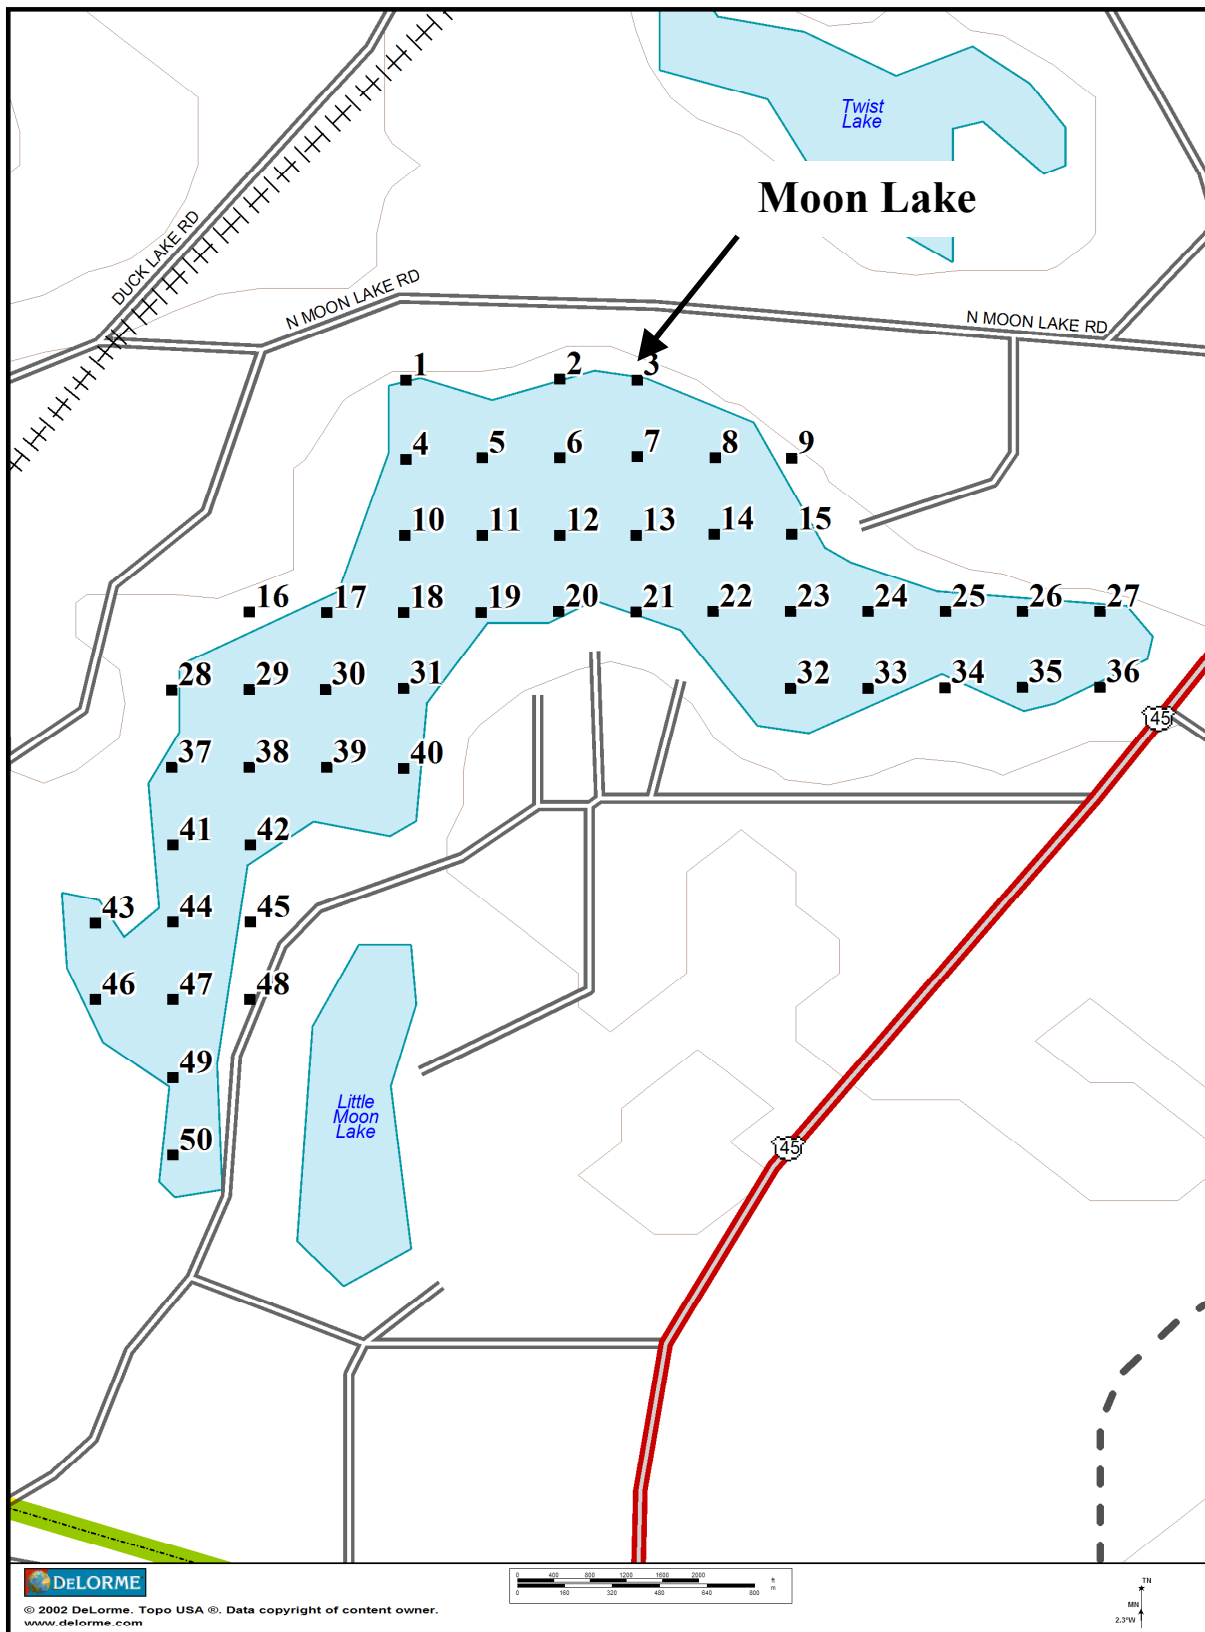
Figure 17. Moon Lake, Gogebic County, MI, aquatic plant survey locations – 2002. Squares on lake map indicate discrete GPS sampling points

Moon Lake had a surface area of 93 acres (Figure 17), with a mean depth of 20 ft and a maximum depth of 40 ft. The water was very clear with an MRD of 39 ft (Table 1). Only about 34 percent of the lake had some vegetation based on survey data, but 100 percent of sample points fell within the MRD (Table 2) because of the extremely clear water. The substrate was mostly hard bottom consisting of rock, gravel, or sand. The most common species (Table 17) were the floating leaf plants such as *Brasenia schreberi*, *Nuphar lutea* ssp *variegata*, and *Nymphaea odorata*, and emergent plants including *Sparganium augustifolium*, *Juncus effusus*, and *Dulichium arundinaceum*. Submersed plants were rare and included *Eleocharis acicularis*, *Eriocaulon aquaticum*, *Juncus pelocarpus*, and *Myriophyllum tenellum*. The total number of species included was 12, the *I* was 26, and the CoC<sub>avg</sub> rating was 7.5. Based on the MRD, Eurasian watermilfoil theoretically could colonize 100 percent of the lake. Substrate type and plant species that occur in the lake indicated that Eurasian watermilfoil populations might not reach this extreme level. Localized infestations, however, could significantly displace native submersed plant populations.

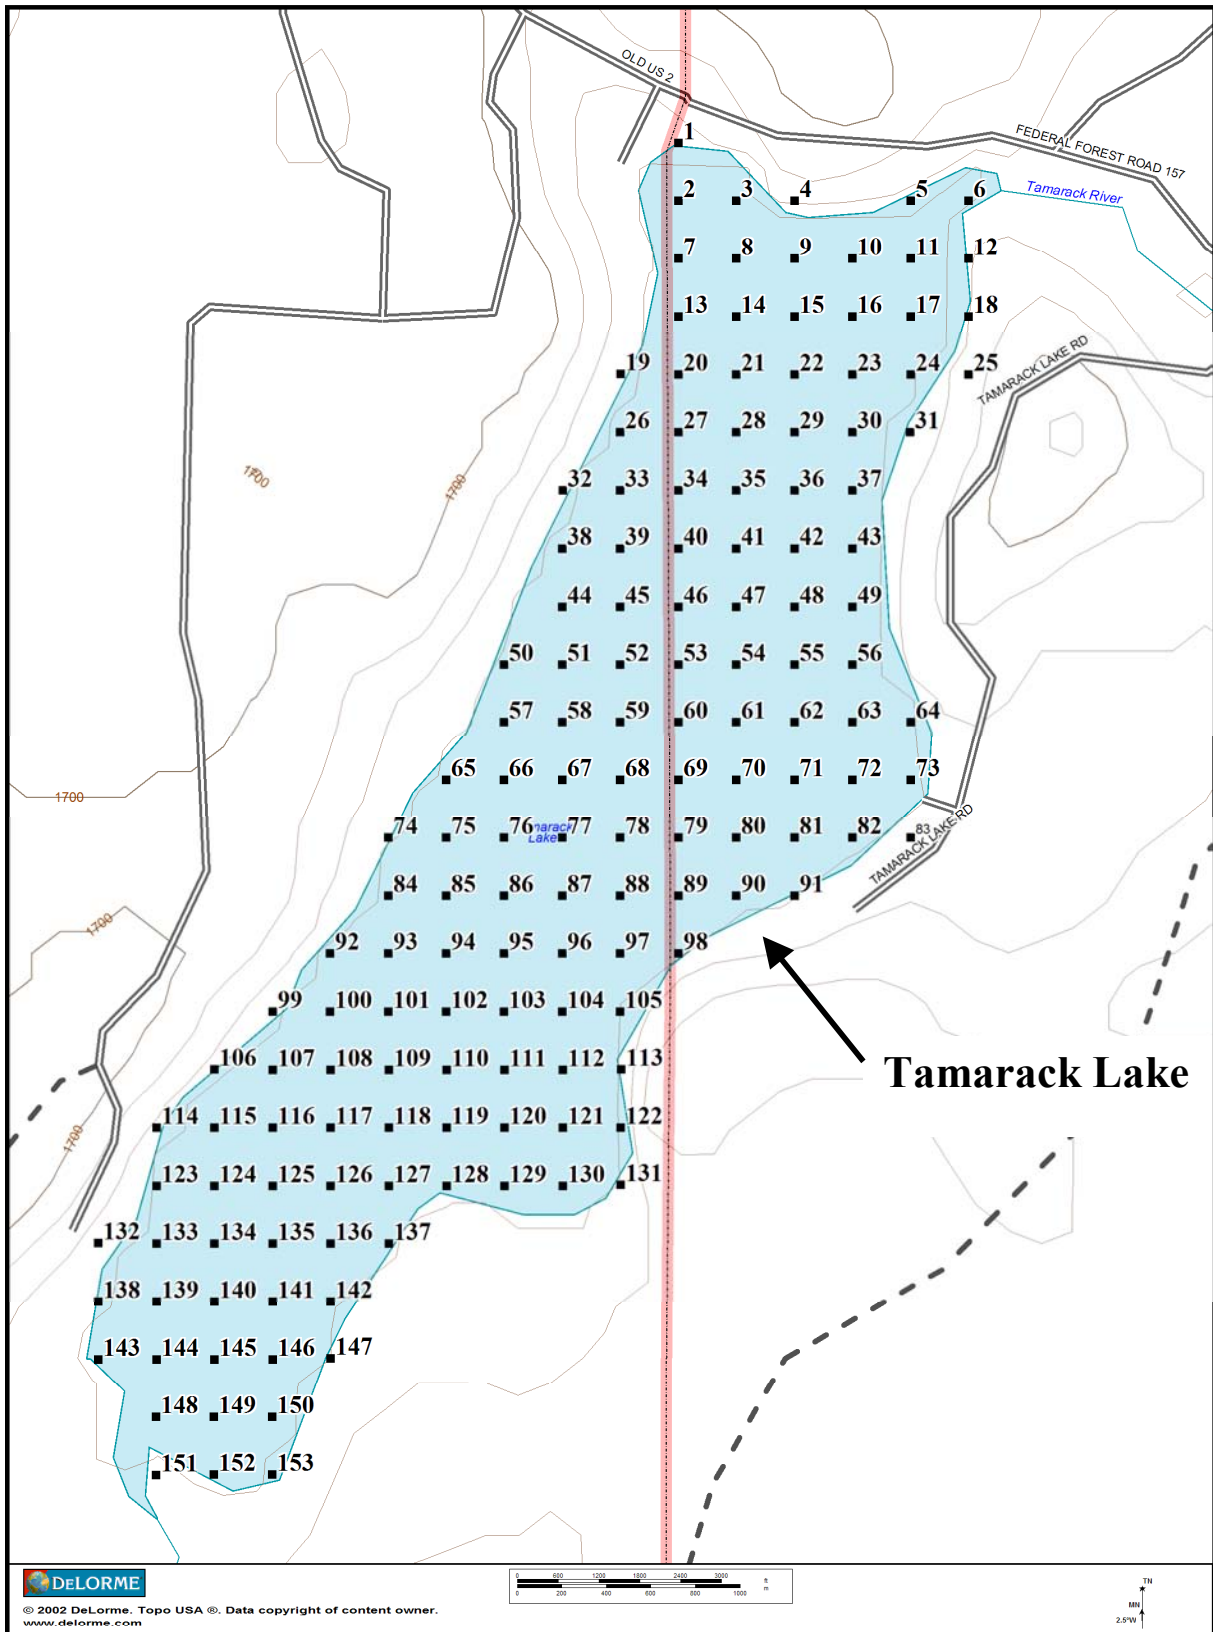
Figure 18. Tamarack Lake, Gogebic County, MI, aquatic plant survey locations – 2002. Squares on lake map indicate discrete GPS sampling points

Tamarack Lake has a surface area of 283 acres (Figure 18) with a mean depth of 11 ft (Table 1). The water was darkly stained with humic acids and tannins; therefore, clarity was relatively poor with an MRD of only 9 ft (Table 1). Consequently, only about 18 percent of the lake has some vegetation based on survey data, and only 33 percent of sample points fell within the MRD (Table 2). The substrate was mostly hard bottom consisting of rock, gravel, or sand, except for wetlands at the southwest end where a stream flowed into the lake. Sediment near the stream was soft and rich in organic matter. Dense plant stands including native pondweeds and milfoils were concentrated here. Stands of *Vallisneria americana* and the floating leaf plant *Nymphaea odorata* scattered in other parts of the lake (Table 18). The total number of species was 14, the *I* was 22.4, and the  $CoC_{avg}$  rating was 6.0. Eurasian watermilfoil could become established in up to 33 percent of the lake based on the MRD. The substrate and plant survey data indicated that Eurasian watermilfoil may not reach widespread nuisance levels, but could reach nuisance levels in localized areas. These localized infestations could significantly displace native submersed plant populations.

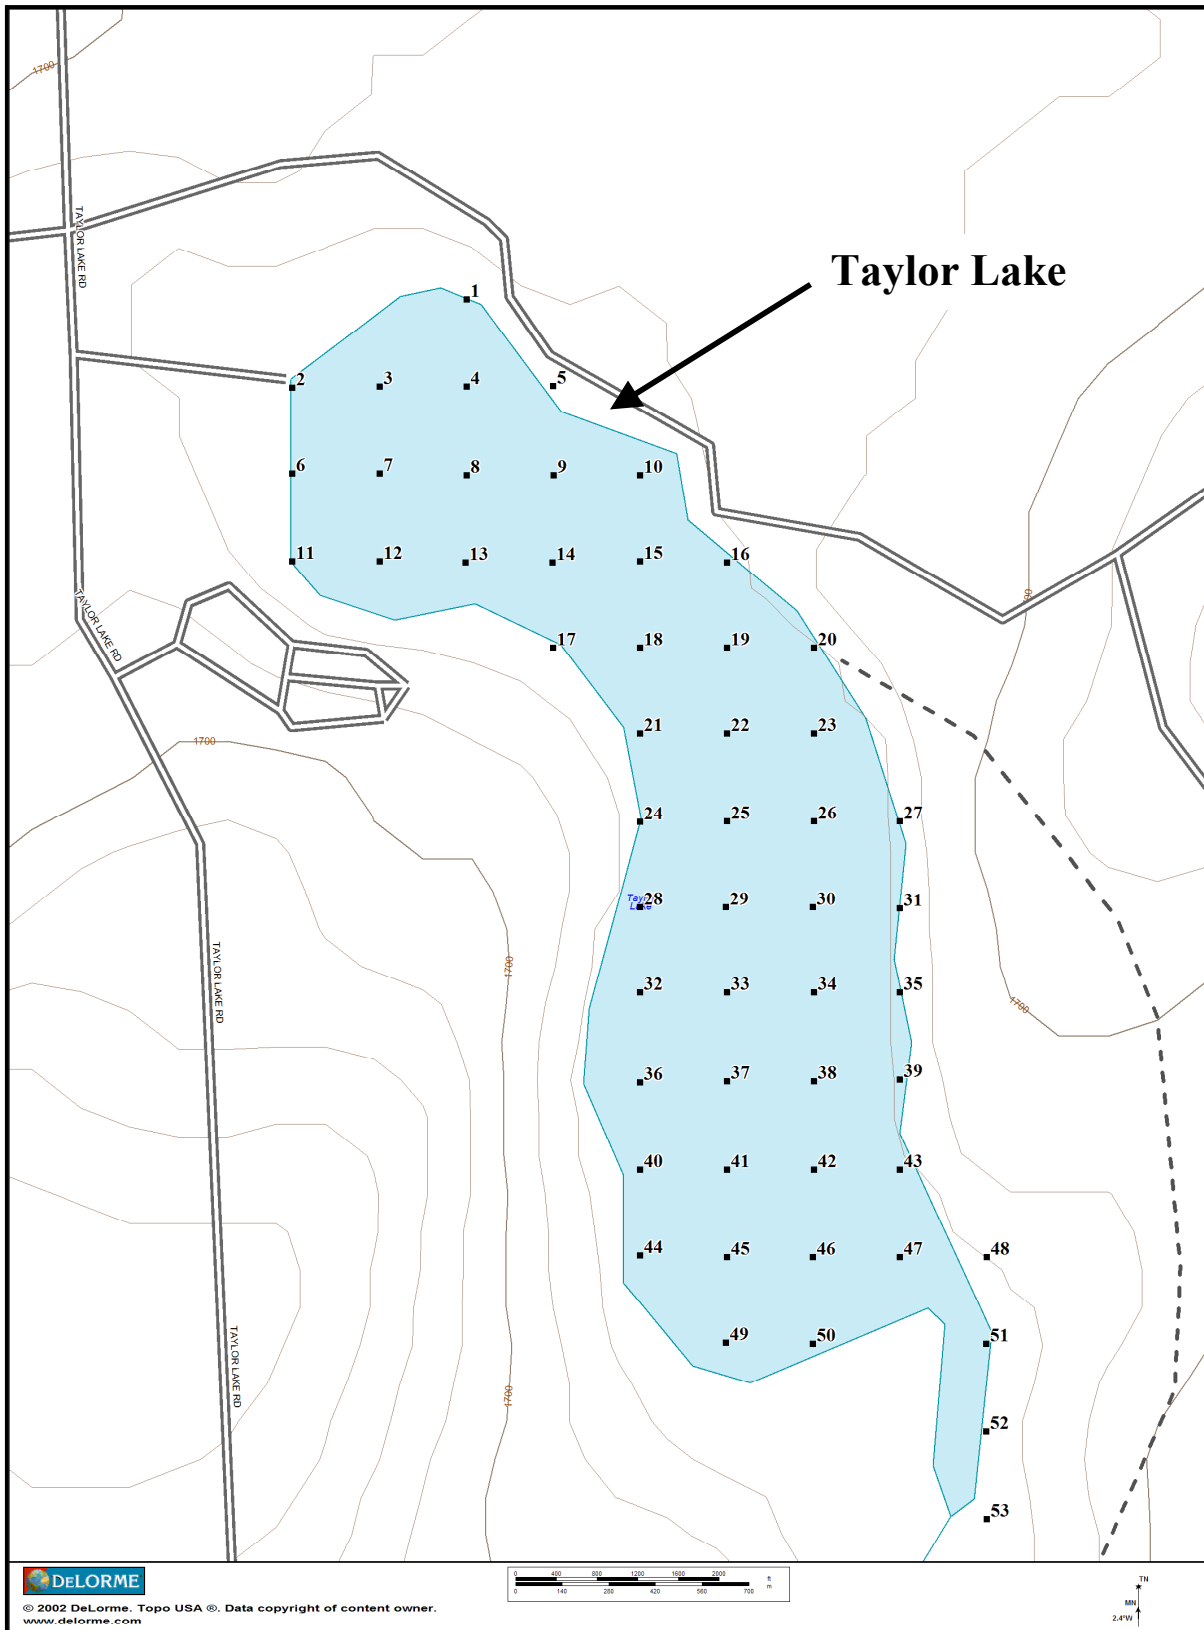
Figure 19. Taylor Lake, Gogebic County, MI, aquatic plant survey locations – 2002. Squares on lake map indicate discrete GPS sampling points

Taylor Lake has a surface area of 110 acres, with a mean depth of 20 ft (Table 1). Although relatively undeveloped, a small USFS campground is located at the side of the lake (Figure 19). The surrounding shore is generally steep with a drop-off. The 40-ft maximum depth is reached near the center of the lake. Shallower flats near the lake inlet at the north end and outlet at the south end have soft silty organic sediments. The lake had an MRD of 9.8 ft (Table 1).

About 23 percent of the lake has some vegetation based on survey data, and 31 percent of sample points fell within the MRD (Table 2). The broad inlet flowing through a peatland area had the most diverse vegetation in Taylor Lake with a mix of many floating, emergent, and submerged species (Table 19) such as *Brasenia schreberi*, *Potamogeton natans*, *Nuphar lutea ssp variegata*, *Najas flexilis*, *Utricularia vulgaris*, and other species. The outlet, Taylor Creek, is in a broad bay with floating vegetation of *Brasenia schreberi* and water lilies with pondweeds beneath. Otherwise vegetation is fairly sparse and confined to a narrow belt along the shoreline. *Brasenia schreberi* is the most common plant in the lake, occurring on half of all plots (Table 4), at both inlet and outlet areas and in shallow locations along much of the shore. *Utricularia vulgaris* is also widespread (31 percent of all plots). There were 22 species found in Taylor Lake with a  $CoC_{avg}$  rating of 6.4 and an *I* of 30. Eurasian watermilfoil could become established in up to 31 percent of the lake based on the MRD. The substrate and plant species that occurred in the lake indicated that Eurasian watermilfoil could reach nuisance levels with respect to recreation and aesthetics. Infestations could also have significant adverse impacts on the submersed plant populations. Once established in Taylor Lake, Eurasian watermilfoil could quickly spread to other lakes in the area via boat traffic, water currents, and animals.

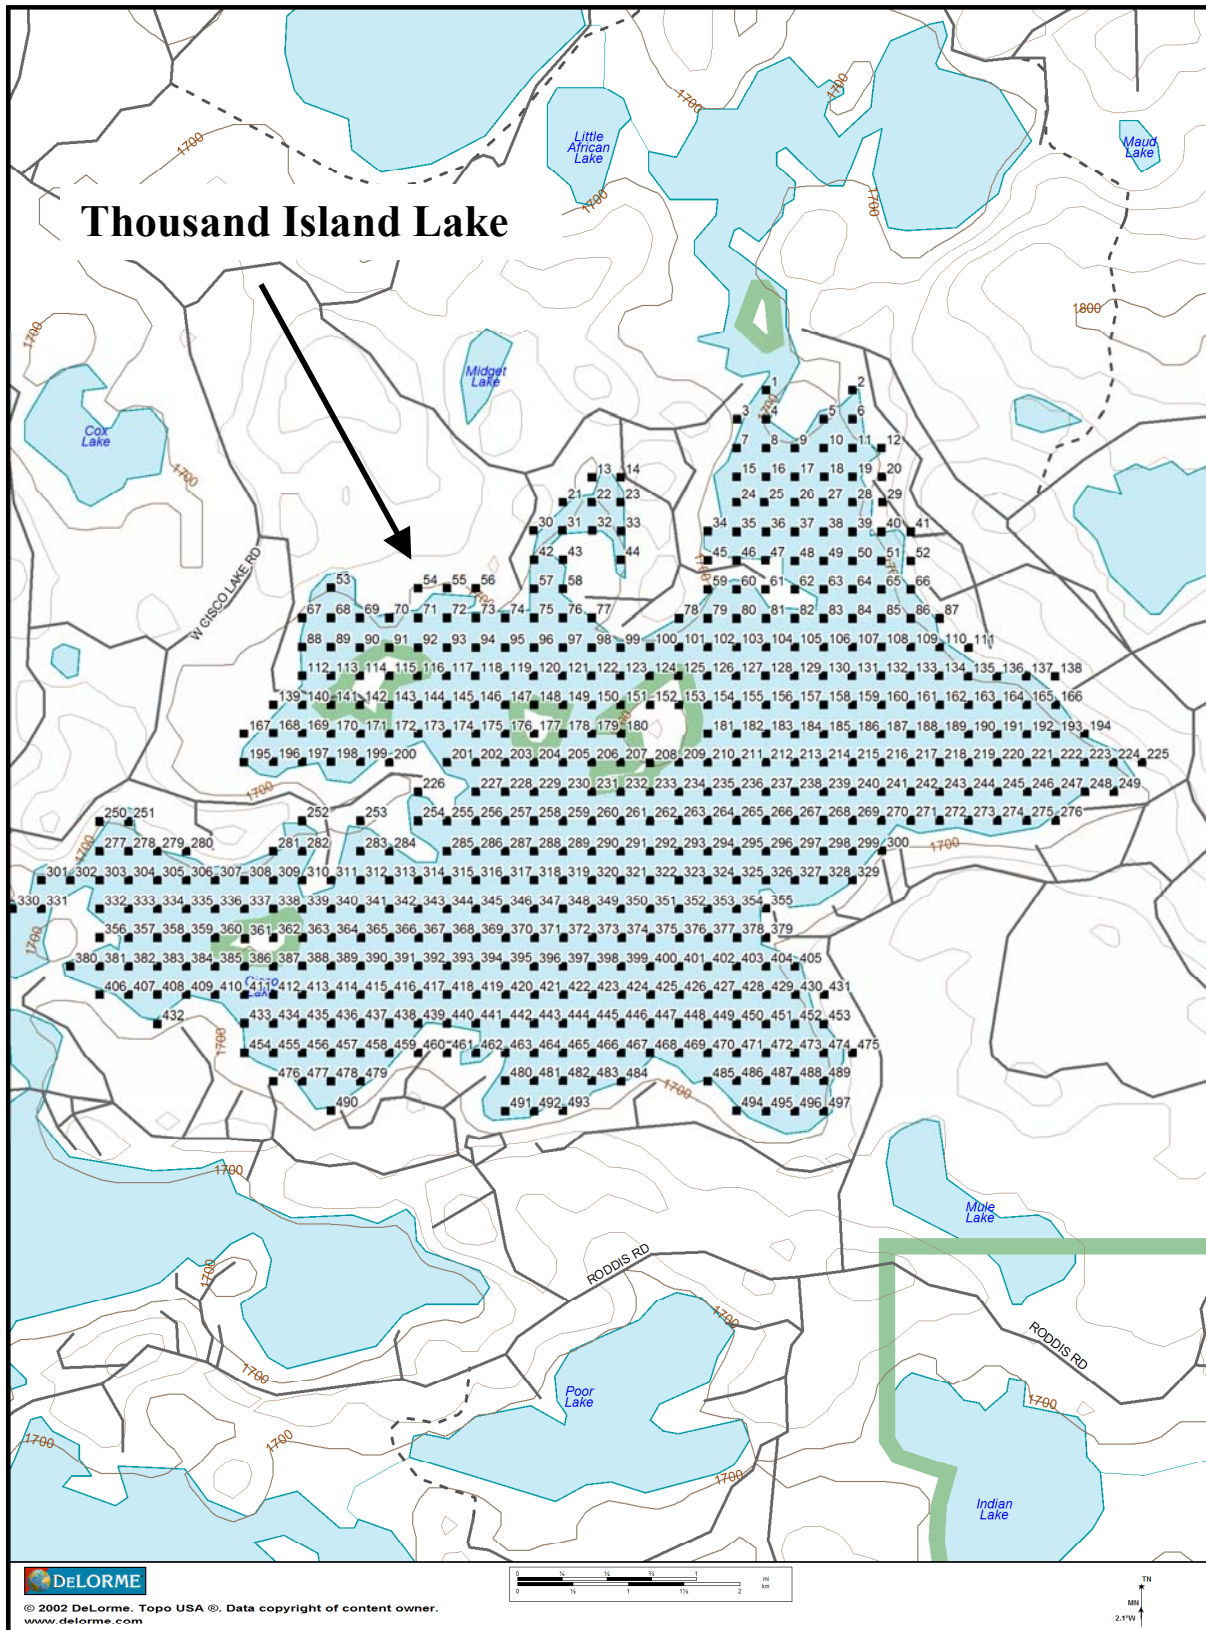
Figure 20. Thousand Island Lake, Gogebic County, MI, aquatic plant survey locations – 2002. Squares on lake map indicate discrete GPS sampling points

Thousand Island Lake is the largest lake in the Cisco Chain of Lakes. It has a surface area of 1,000 acres (Figure 20) and a mean depth of 27 ft (Table 1) with a maximum depth of 95 ft. Numerous homes and resorts line the lakeshore. The water was relatively clear with an MRD of 18 ft (Table 1). Thousand Island Lake is connected to Big Africa Lake, which can be reached by boat through a stream that feeds into the lake's northernmost bay. Cisco Lake is connected to Thousand Island Lake by a channel at the southwest end of the lake. About 34 percent of the lake has some vegetation based on survey data, and 42 percent of sample locations fell within the MRD (Table 2). The northern and western bays were relatively shallow (< MRD) with mostly soft organic sediments that supported large stands of pondweeds (Table 20), including *Potamogeton zosteriformis*, *P. robbinsii*, *P. richardsonii*, and *P. epihydrus*. *Elodea canadensis* and *Myriophyllum sibiricum* were also common in these areas. The southeast and east sections of lakes were much deeper (>90 ft in some areas), and the substrate tended to be gravel or sand. Many plants were common in the shallow areas, but this area was too deep (> MRD) to support aquatic plants. The number of species found was 31, the greatest of any lake surveyed. The CoC<sub>avg</sub> rating was 6.5, and the *I* was 36.0. Eurasian watermilfoil could become established in up to
